Mole Robot (MolBot): Development of pipe damage detector robot

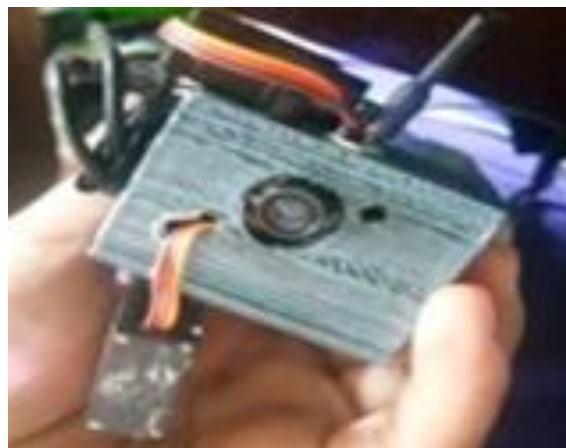
Figure 3: Testing of the MolBot

Testing the live video feedback and viewing it in different platforms using the receiver and transmitter technology.

For the live video streaming response feature of the MolBot a 720p FPV Camera with transmitter is mounted to the Framework. A basic FPV set-up consists of an on-board camera, mounted on the vehicle, which is then connected to a small, mounted transmitter. Typically runs on a 5.8GHz frequency. The transmitter sends a signal to a receiver that is linked to a viewing device, such as a portable monitor or FPV goggles. The camera receiver can be connected to any monitor, Smartphone device, Tablet, and goggles for live streaming. The algorithm (Cui et al., 2018; Lu & Lu, 2019) then processes the image for the detection and gives the feedback of classifying the object. The accuracy depends on the quantity of the dataset and most of the data passes through data augmentation.

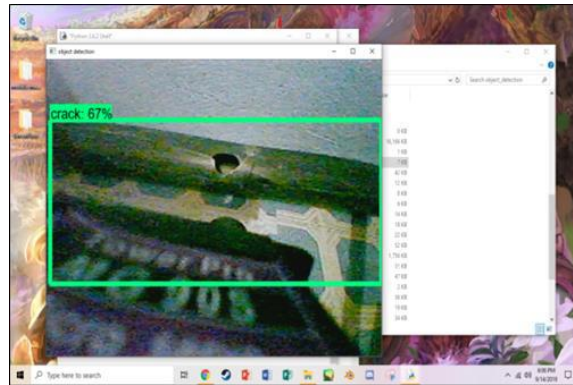
The researcher first tested the ability of the MolBot to detect cracks and damages on pipes from the inside to view if it would be as accurate as the result from the outer side of the pipe. Figure 4 show the Mole Robot's Camera with Automatic Image-based crack Detector tested from the outside of the pipe. The MolBot can detect crack from the live video transmitted from the robot to the video platform. Figure 5 shows the Mole Robot's Camera with Automatic Image-based crack Detector tested from the inside of the pipe. This study on Mole Robot (MolBot): Development of pipe damage detector robot can detect cracks accurately for about 67% as shown in the figure 5. The Mole Robot can also successfully move inside the stable pipe. In figure 6, another test was conducted by detecting crack not only from pipes but also in walls. The detection was as accurate as in processing damages on pipe's inner and

Figure 4. Detecting damages from outside of the pipe.

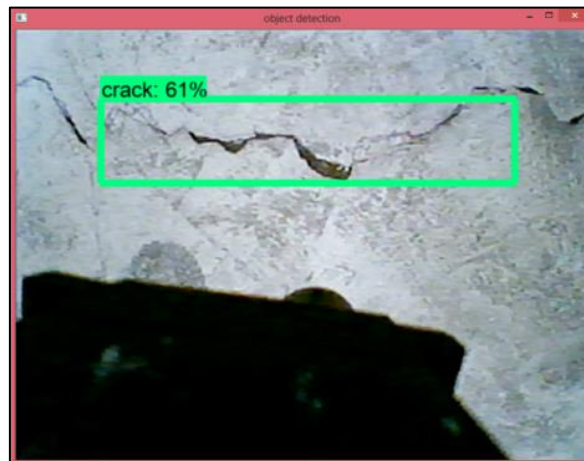
outer core. The plane detection shows the pattern that it can be used in different application such as concrete walls, wood, and any surface which will have a damage or crack using the same dataset and algorithm.

Figure 6. Testing the application in different area.
